## Inventory Of Abandoned Mine Ponds/Dams On The Jos-Bukuru North-Central Nigeria Using G.I.S And Remote Sensing Technique

*GIS and Remote Sensing was used in mapping out all abandoned ponds around the Jos-Bukuru area. A total of 100 major ponds and 80 minor ponds were mapped out all spread across the area of study.*

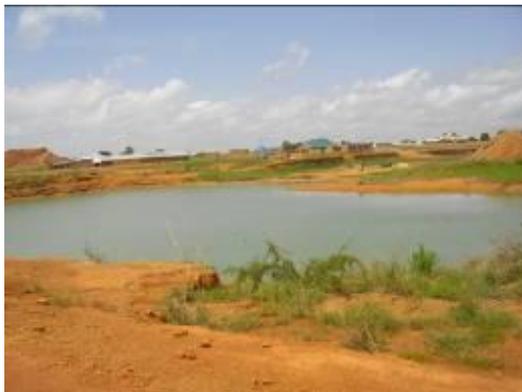
*Plate 1: An open pond around Du village*

Field work was also carried out to confirm that features mapped on the images as area covered by the ponds were not just a resemblance of what we are mapping, visit was made to the open ponds to confirm their locations. Pictures of these ponds were also taken to present an aerial view of some of the mining pond (Plate 1-4).

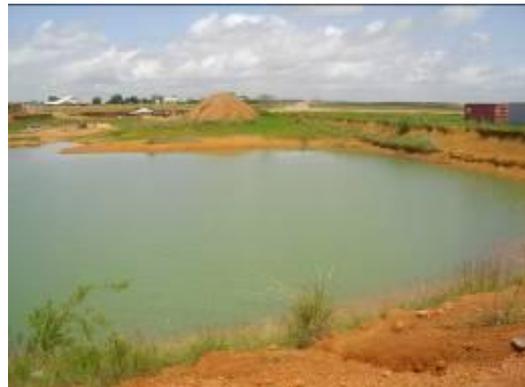
*Plate 2: An open pond around Rayfield road*

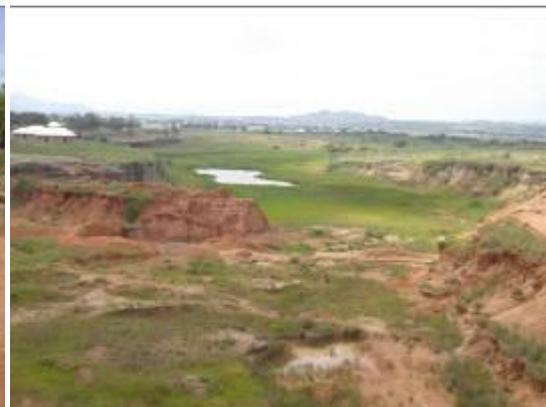
*Plate 4: An open pond at Ran Kwangdu*

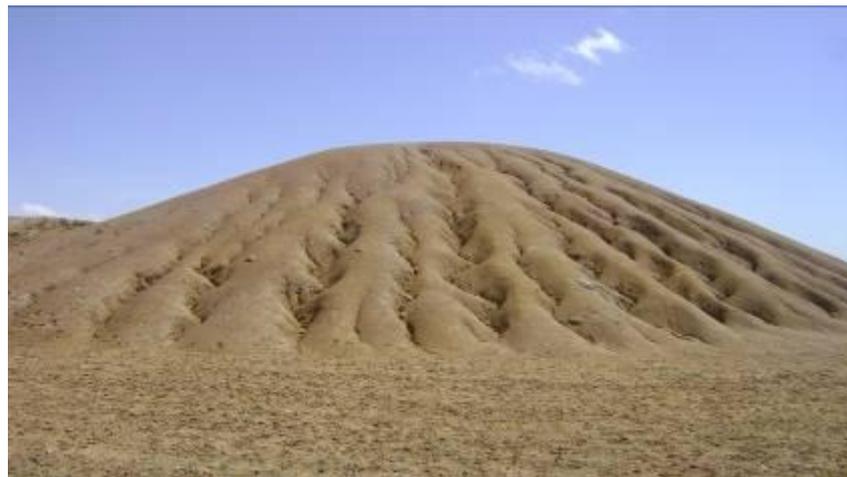
***Plate 5: Waste pile at one of the sites***

Abandoned mines may include disturbed lands and unprotected slopes that are susceptible to erosion. Uncontrolled surface drainage can remove soils and may make large areas unstable. Also the piles of overburden dumps around the banks of these ponds (Plate 5) have over the years been a source of concerned as current research being carried out by a department at the national centre for remote sensing during their preliminary report shows that these heaps has high level of radioactive elements which can be devastating to lives. Reworking of the previously areas have been reported by Eziashi (1998)
