Corrosion Fatigue of Alloys Containing Chromium and Molybdenum

ABSTRACT

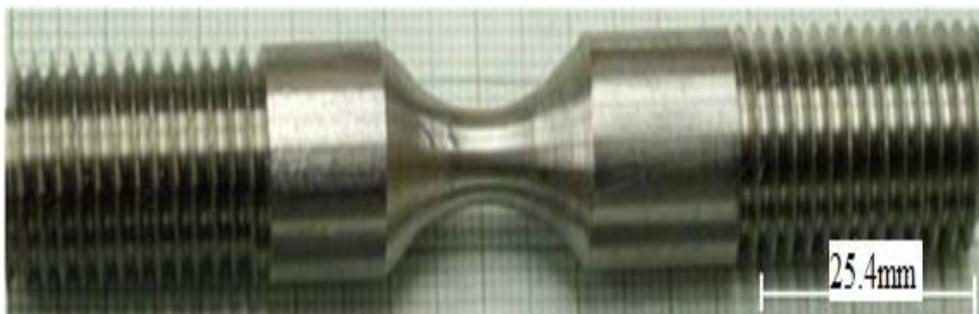
Figure 1. Fatigue test specimen before testing.

The test was conducted using high-capacity servohydraulic fatigue testing machines. Fatigue test specimens were machined from the as received materials as shown in Figure 1. The test specimen was mounted between the actuator and the load cell by screwing it into the test fixture. Details of the corrosion cell configurations and dimensions are shown in Figure 2. An O-ring was installed at the bottom of the cell to permit transfer of force to the specimen while preventing leakage of the solution as shown in Figure 3.

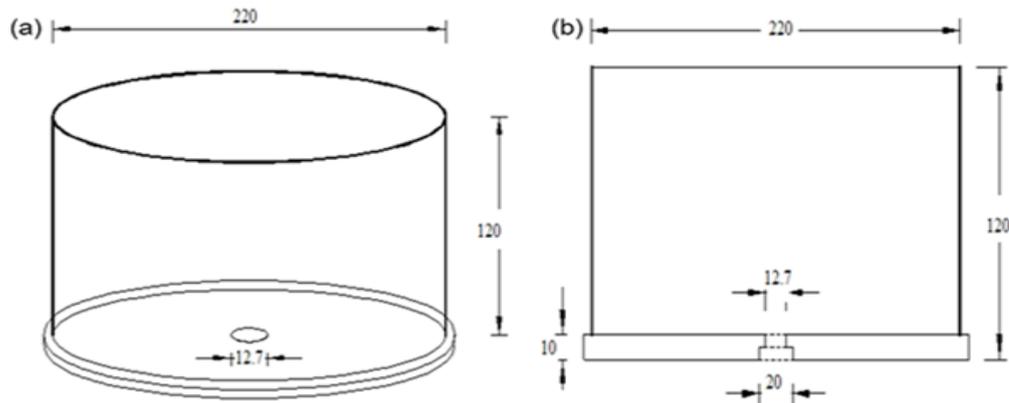
Figure 2. Schematic design of corrosion cell (a) Dimensions of corrosion cell and (b) Cross section in (mm)

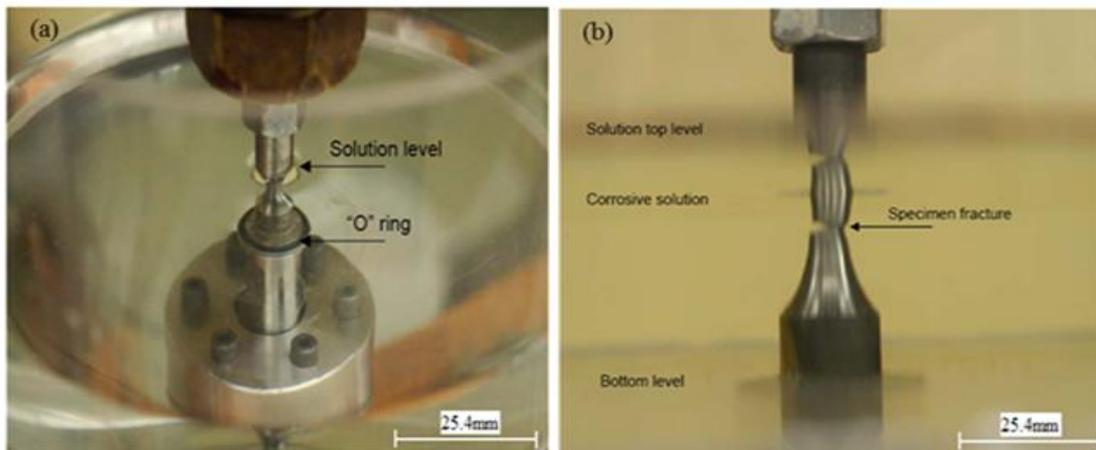
Figure 3. Fatigue test system: (a) specimen before fracture with O-ring installed, and (b) specimen after

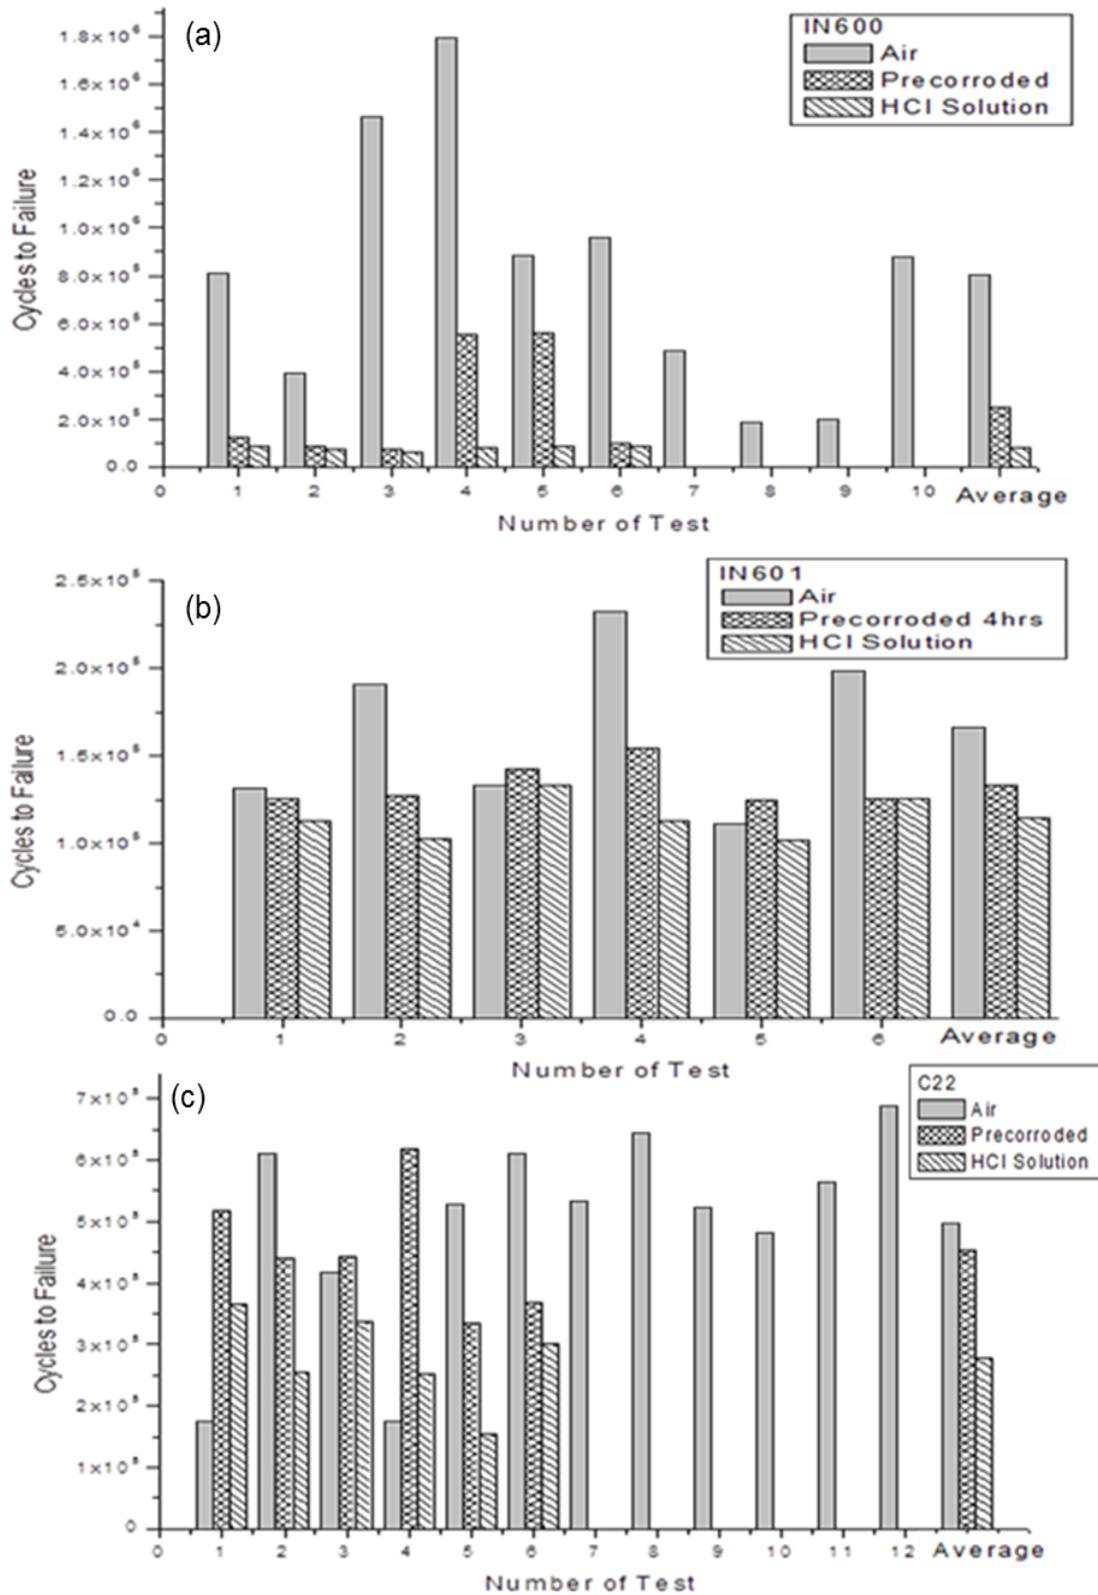
Figure 4. Effect of pre-corrosion and a concentrated HCl solution at pH 0 on fatigue behavior of (a) IN600 at 480MPa, (b) IN601 at 532MPa, and (c) C22 at 532MPa.

Figures 4 and 5 show that, in general, the number of cycles to failure for all the alloys tested was highest for fatigue testing in air without pre-corrosion, lower for pre-corroded specimens fatigue tested in air, and lowest for specimens fatigue tested in a corrosive environment without pre-corrosion. More detailed observations follow.

The fatigue results for IN601 immersed in HCl at pH = 0.0 presented in Figure 4 (b) show that the corrosive environment has an effect on the fatigue life of the specimen. In contrast, the specimens pre-corroded for 4 hours exhibited the largest (average) fatigue life, and the specimens tested in air also had a higher fatigue life than in the corrosive environment.

The fatigue results for alloy C22 given in Figure 4 (c) show that the corrosive environment reduced fatigue life, while the fatigue life of specimens tested in air after 6 hours of pre-corrosion is higher than the results for the specimens fatigue tested in the HCl solution. In both cases fatigue tests ran for an average of about 6 hours (200,000 cycles at 36,000 cycles per hour).

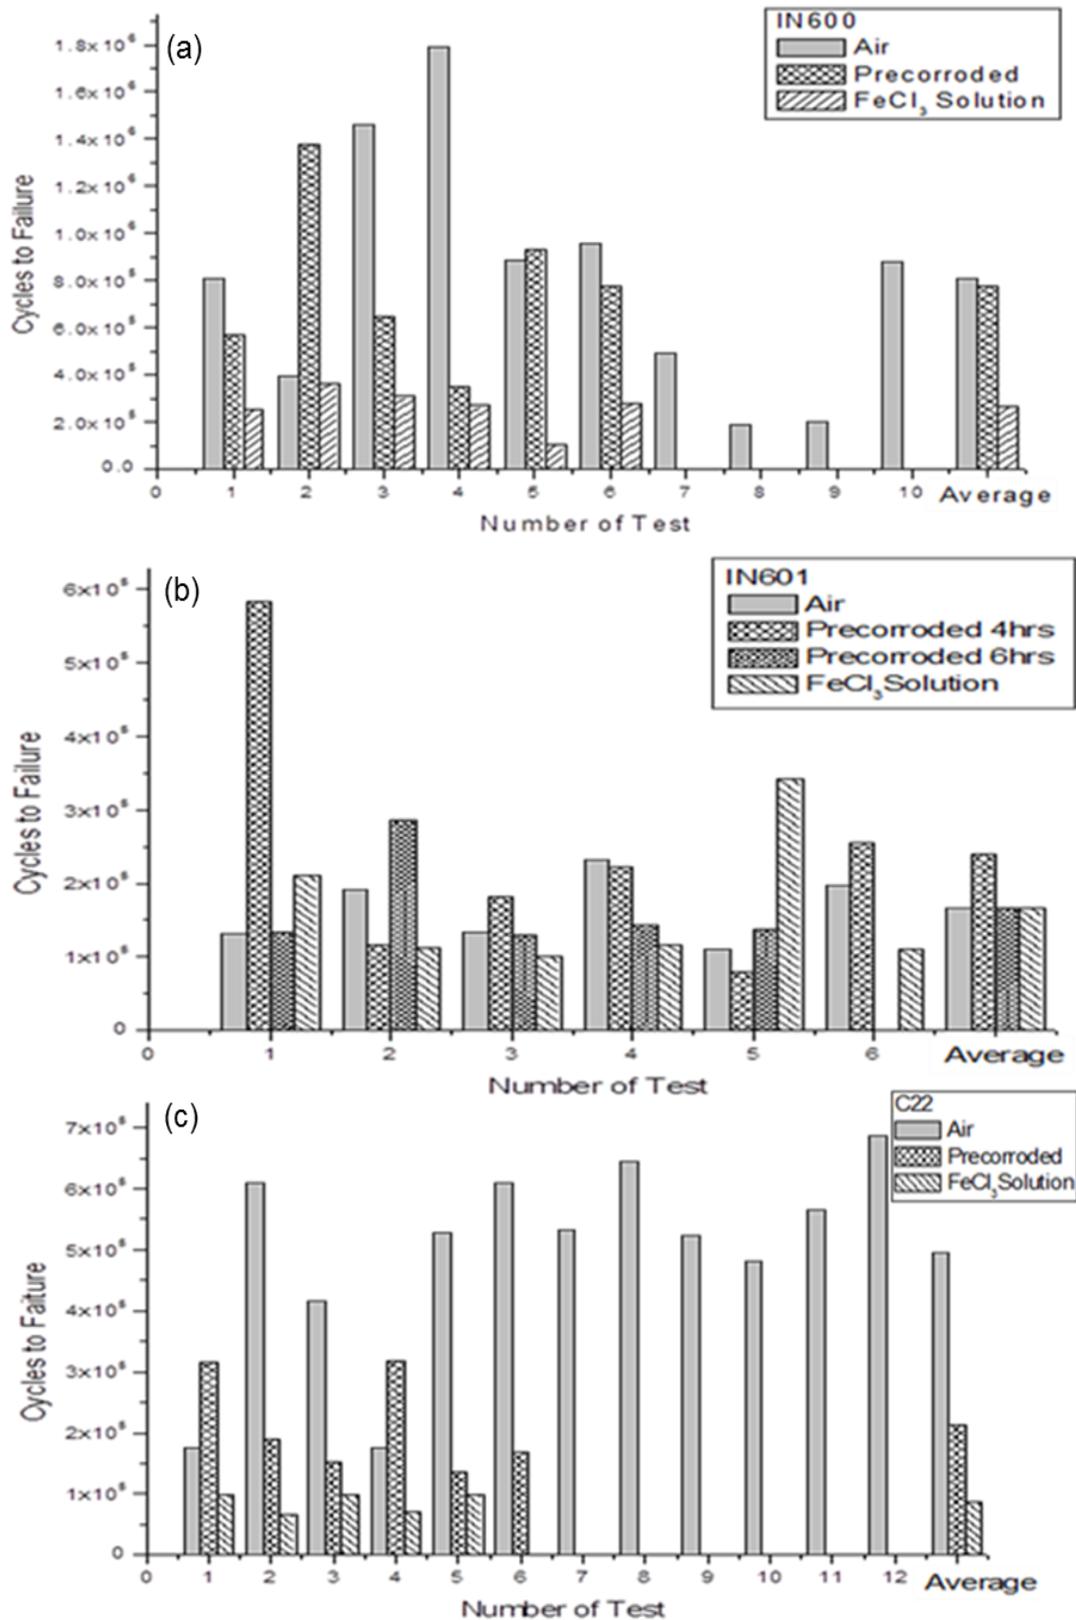
Figure 5. Effect of pre-corrosion and 10 % FeCl₃ solution at pH 0 on fatigue behavior of (a) IN600 at 480MPa, (b) IN601 at 532MPa, and (c) C22 at 532MPa.

The fatigue results for IN600 tested in 10 wt. % FeCl₃ solution at pH = 0.0 in Figure 5 (a) show that the fatigue life for the specimens fatigue tested in this solution were shorter than those for specimens pre-corroded for 7 hours prior to testing in air. The standard deviations in the data from the fatigue testing are shown in Figure 6 and are seen to be quite similar as between the three different alloys and testing conditions.

The fatigue results for IN601 in 10 wt. % FeCl_3 solution at $\text{pH} = 0.0$ as presented in Figure 5 (b) show that the pre-corrosion in solution has a great effect on the fatigue life of IN601. The fatigue life is similar to that obtained for IN601 in an HCl solution at pH of 0.0 and is indicative of both the toughness and the corrosion resistance of this alloy.

The fatigue results for alloy C22 in 10 wt. % FeCl_3 solutions at $\text{pH} = 0.0$ are presented in Figure 5 (c) which shows that pre-corrosion for 7 hours followed by fatigue testing in air has about the same effect as fatiguing in solution. (The fatigue life in solution is about 200,000 cycles / second). It may therefore be concluded that for alloy C22 in 10 wt. % FeCl_3 solution at $\text{pH} = 0.0$ there is an interaction between the solution and the alloy at the crack tip.

The test results indicate that for both alloys IN600 and C22 there is an interaction between the corrosive HCl and FeCl_3 solutions and the alloy at the fatigue crack tip which shortens the fatigue life over that of specimens pre-corroded for a similar length of time. Further, the fatigue life of IN601 is not greatly affected by the presence of HCl solution or 10 wt. % FeCl_3 solution at pH of 0.0 (either diverging pre-corrosion or corrosion in solution). This result is quite unexpected as it follows the expected trend of corrosion resistance increasing with Cr and Mo content. It is the author's opinion that in this particular study the IN601 was not as greatly affected in the pre-corroded specimens in the two aggressive environments as IN600 and C22, due to the higher carbon content in IN601 compared to IN600 and C22. When IN601 is subjected to the corrosive environments used in this research carbide is formed at surface pits. This carbide creates a hardened surface and improves strength (Figure 5 (b)) even though the surface is pitted. It is assumed that the carbide is localized within the pits.

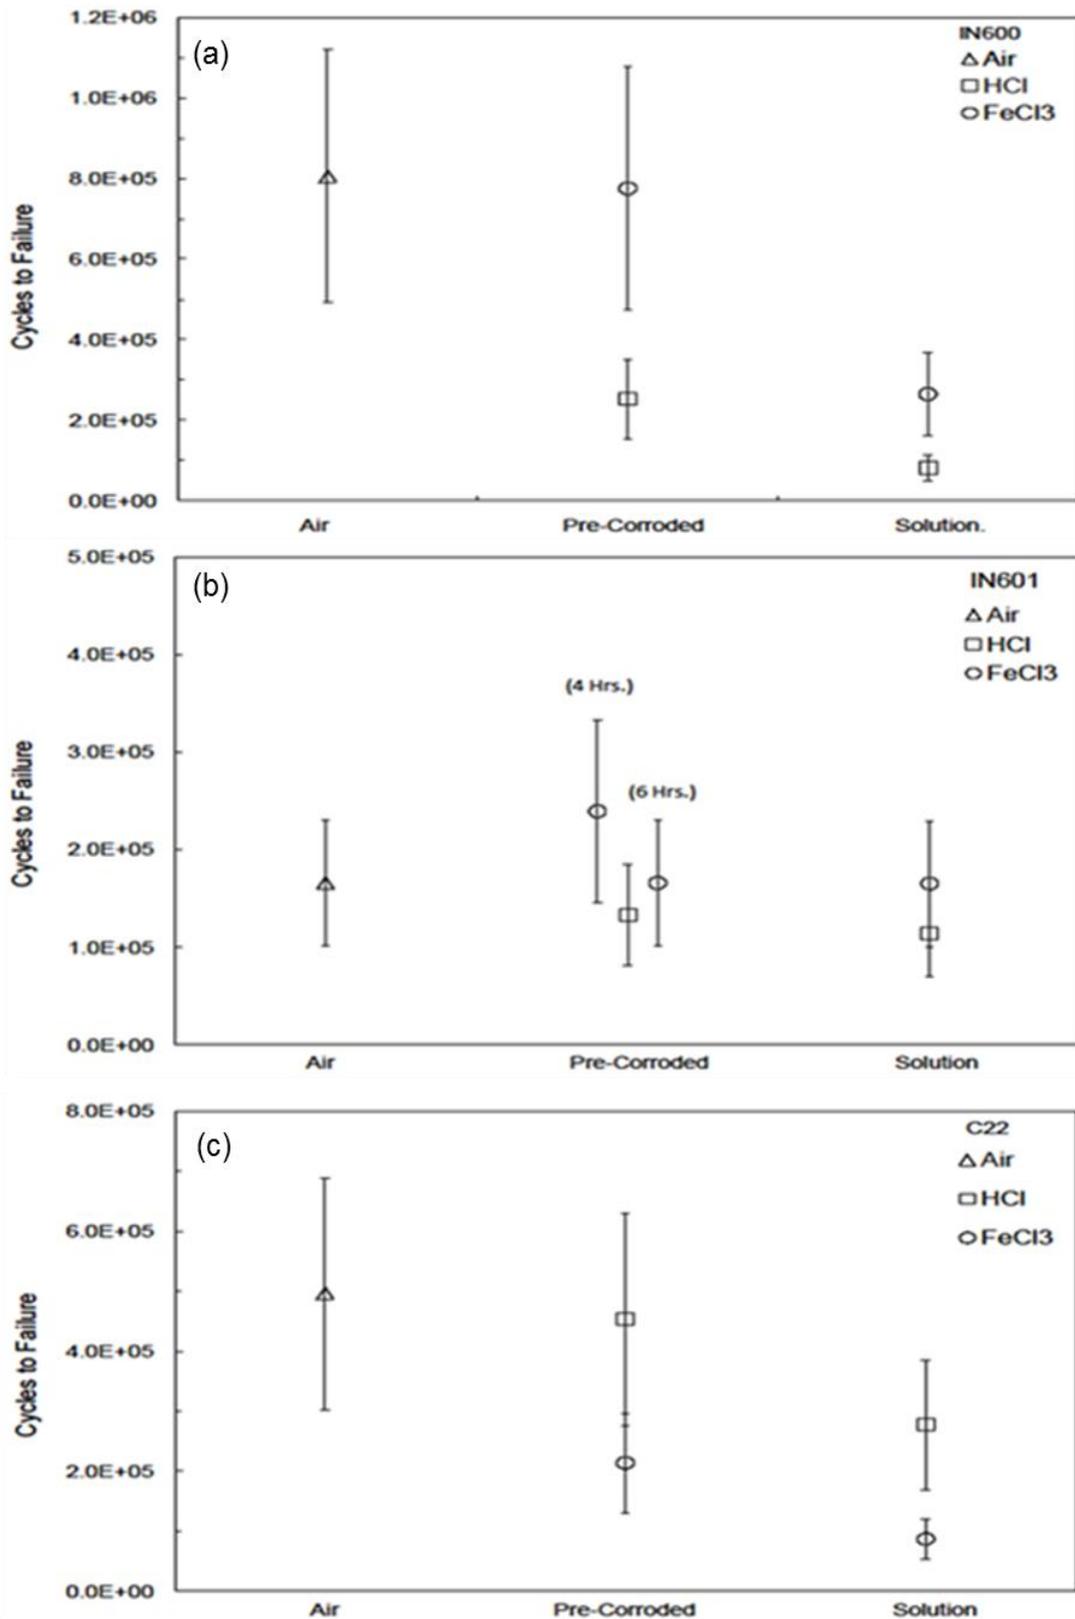
Figure 6. Standard deviations of fatigue test results at pH 0: (a) IN600, (b) IN601 and (c) C22.

The information on standard deviations is particularly significant because these fatigue tests lasted about 7 hours, a similar time that was required for fatigue failure of specimens in solution (about 250,000 cycles at 36,000 cycles per hour).

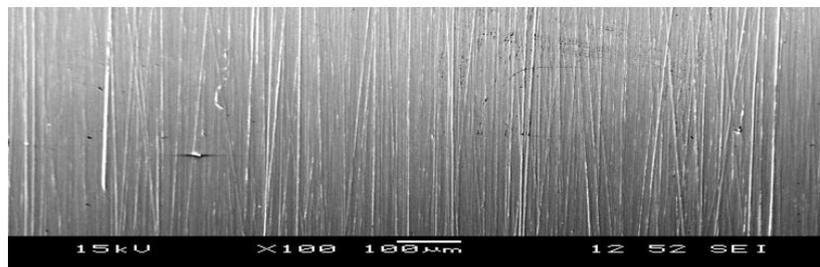
Figure 7. A representative specimen surface prior to any fatigue testing.

Figure 7 shows a representative specimen surface prior to any fatigue testing. In Figure 8 (a), surfaces for IN600 fatigued in air after pre-corrosion in HCl solution at pH of 0.0 reveal many large surface pits. IN601, Figure 8 (b), shows smaller and fewer pits and alloy C22 exhibits only a few small pits (Figure 8 (c)). These results are consistent with the fatigue test results which show a large effect of corrosion for IN600 and much smaller effects for IN601 and alloy C22.

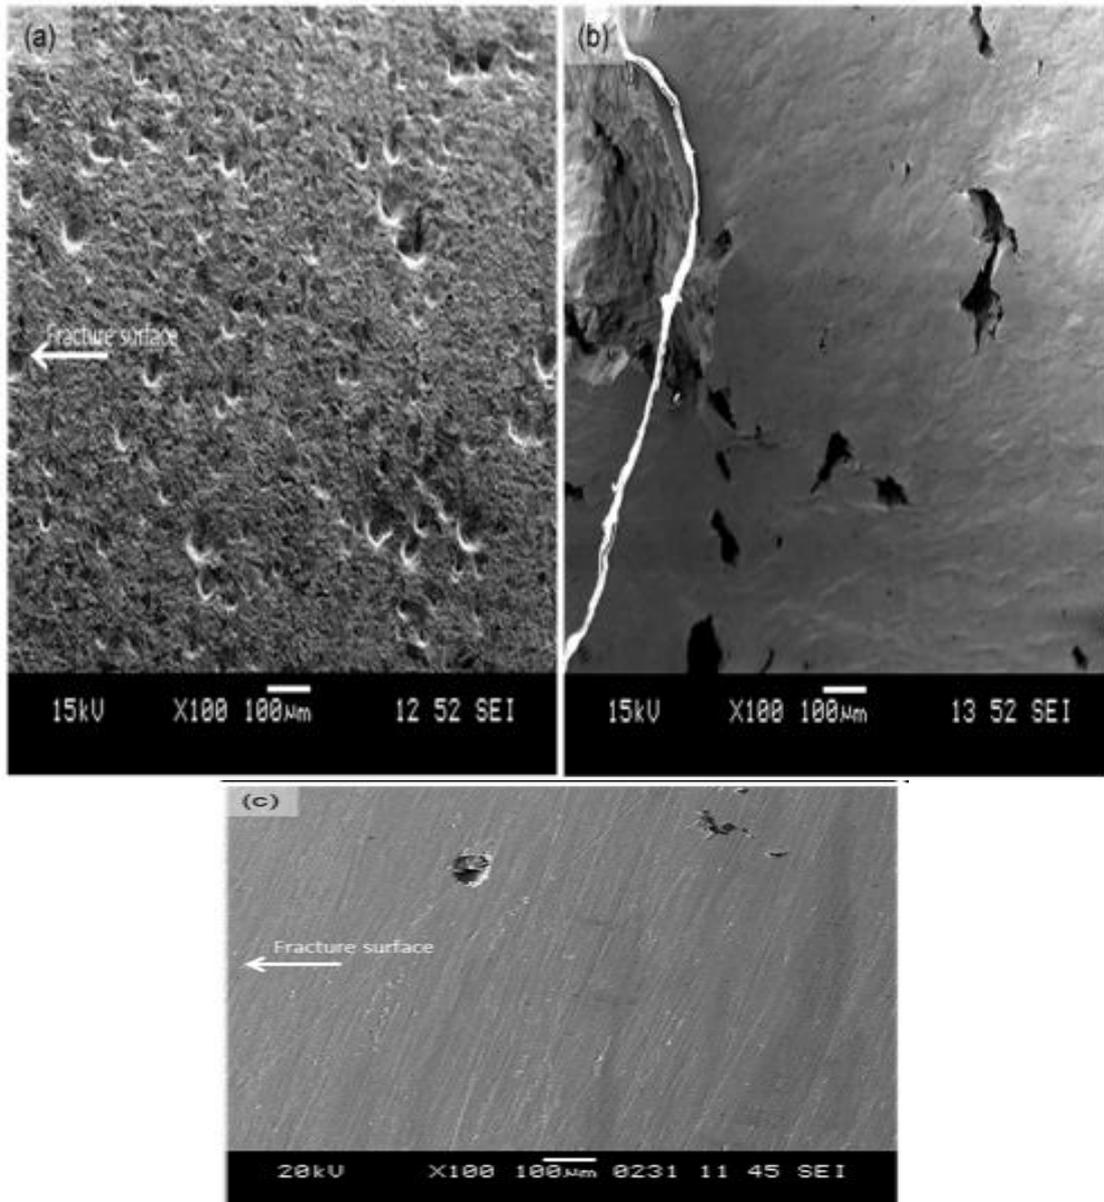
Figure 8. Pits near the fracture surface after pre-corrosion in concentrated HCl solution at pH 0: (a) IN600 for 13 hrs, (b) IN601 for 4hrs, and (c) C22.

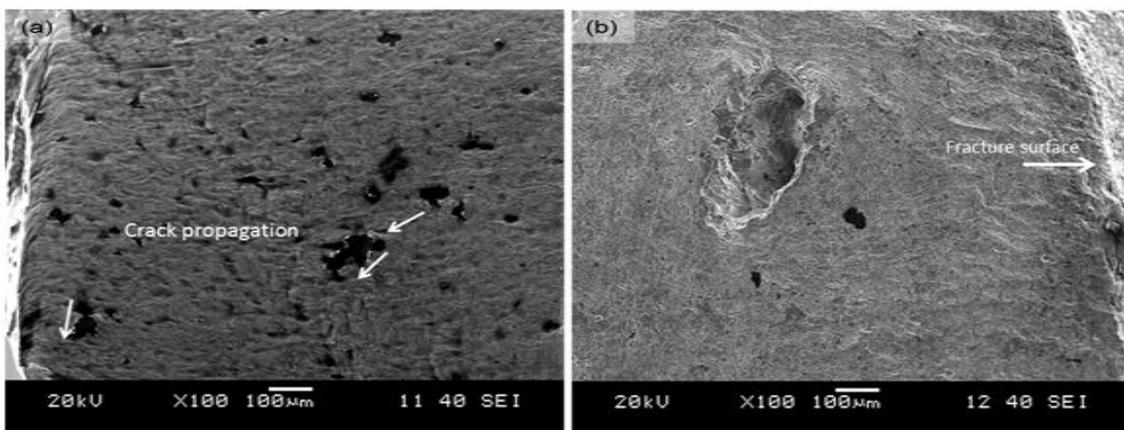
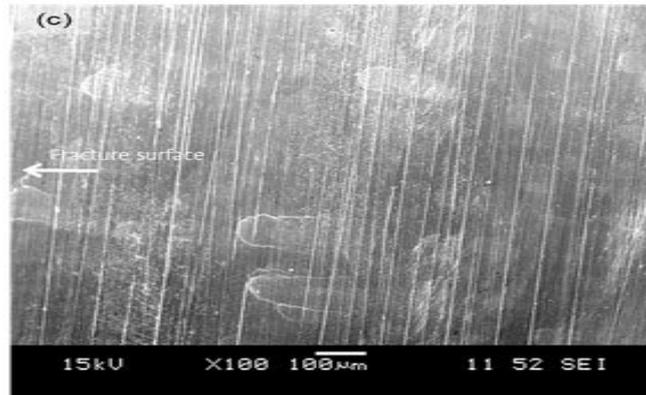
Figure 9 Pits near the fracture surface after pre-corrosion formed by 10% FeCl₃ solution at pH 0: (a) IN600, (b) IN601, and (c) C22.

The specimen surface for IN600 fatigued in air after pre-corrosion in 10 wt. % FeCl_3 solution at $\text{pH} = 0.0$ exhibited extensive pitting as shown in Figure 9 (a). Fewer pits were observed for IN601 (Figure 9 (b)) and almost no pits for alloy C22 (Figure 9 (c)). This data again indicates the inherent strength due to higher carbon content in 601 compared to IN600 and C22. Also, for alloy C22 the reduction in fatigue strength must result from an interaction between the metal and the FeCl_3 solution at the fatigue crack tip since there is little surface pitting to initiate the fatigue crack.

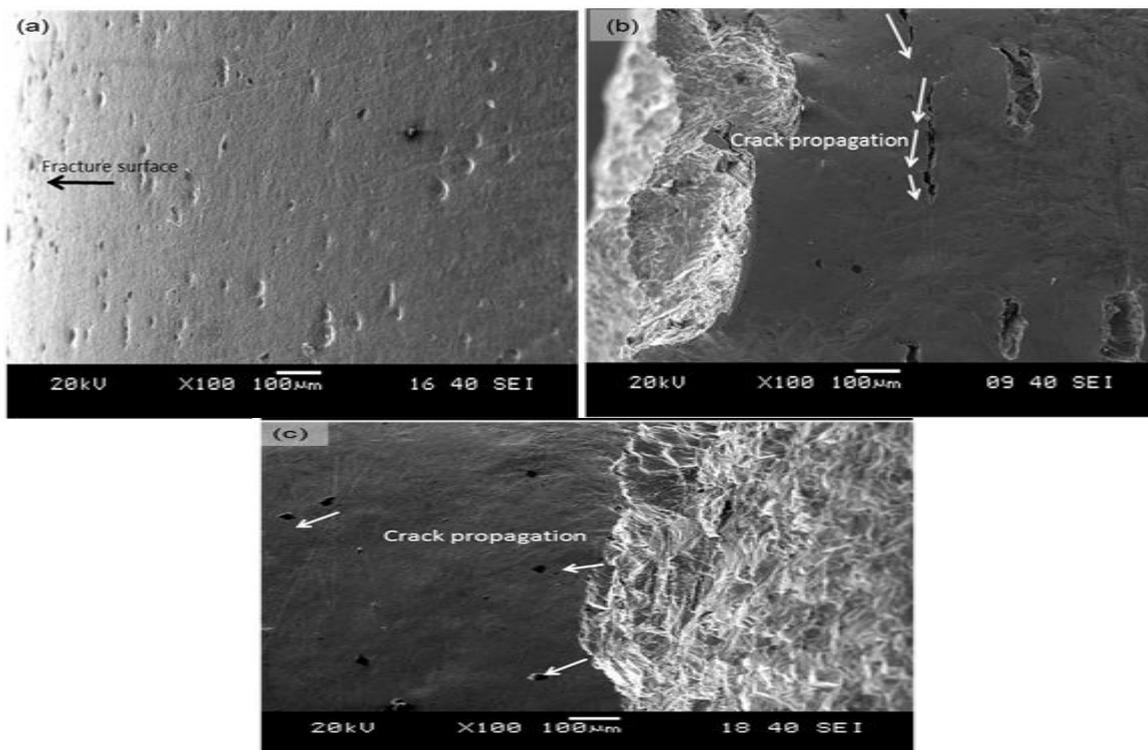
Figure 10. Corrosion pits near the fracture surface after specimen fatigued in concentrated HCl solution at pH 0: (a) IN600, (b) IN601 and (c) C22.

The specimen surface for alloys fatigue tested in concentrated HCl solution at pH of 0.0 and FeCl_3 solution at pH of 0.0 are shown in Figure 10 and Figure 11 respectively. The results are similar to those for the pre-corroded specimens. IN600 exhibits numerous pits (Figure 9 (a)), IN601 fewer pits (Figure 9 (b)), and alloy C22 very minor pits (Figure 9 (c)).

Extensive corrosion pits formed by aggressive environments (HCl) and (10%FeCl₃), such as those in Figure 10 and Figure 11, respectively, may occur at carbide sites or inclusions and appear to be larger closer to the fracture zone (plastic zone). One can observe pits adjacent to fracture zone pits extended from one pit to another adjacent pit while specimens were undergoing fatigue. Each pit becomes a site of crack nucleation with the crack propagating to the next pit and so on, one after the other, until final fracture (Figures 10 and 11).

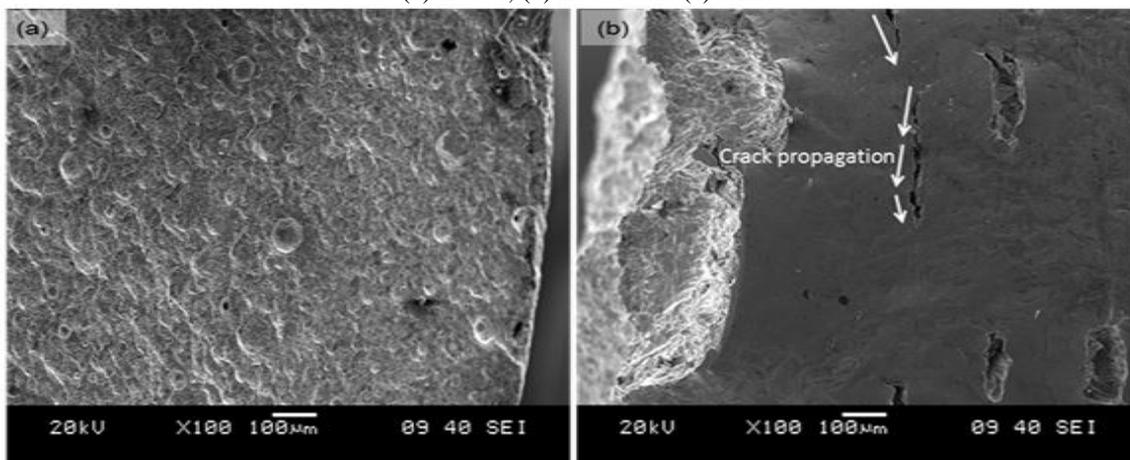
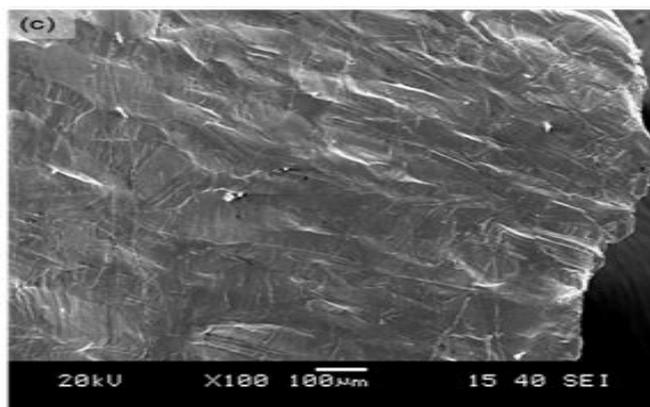
Figure 11. Corrosion pits near the fracture surface after being fatigued in 10% FeCl₃ solution at pH 0 (a) IN600, (b) IN601, and (c) C22.

For 10%FeCl₃ solution at pH of 0.0, IN600 exhibits numerous pits (Figure 11 (a)), IN601 fewer pits (Figure 11 (b)), and alloy C22 almost no pits (Figure 11 (c)). The corrosion resistance of IN601 is likely due to its high chromium content (22.14%), since it is well known that Cr forms a very protective, corrosion resistant Cr₂O₃ oxide layer.
