A Study of Underpinning Methods Used in the Construction Industry in Nigeria

D. Dahiru¹, S.Salau², J.Usman³

^{1, 2 & 3}.Department of Building, Ahmadu Bello University, Zaria – Nigeria.

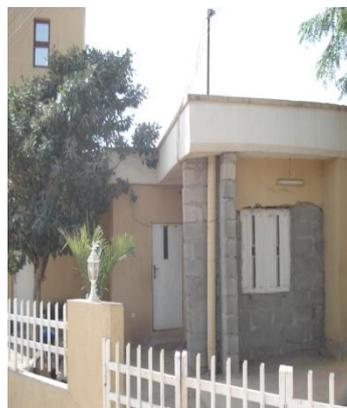
Plate ii: Re-constructed portion of wall

Method Underpinning Used: Corrective measure to arrest the failure was by means of underpinning using traditional continuous strip method and erecting columns at suitable distances to support the loads, while section of 2.0m intervals were demolished and excavated below the existing foundation level and erected upwards to support the walls and roofs.

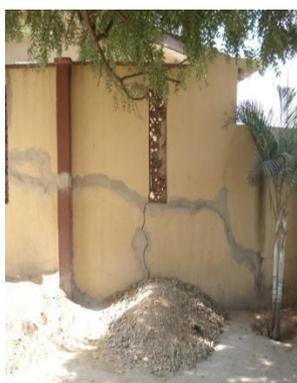
Plate iii: cracks on the wall

Nature of Failure: Barely on completion of the construction work, severe cracks began to appear which prompted the mosque committee to seek professional advice to take care of the failure. Severe horizontal and vertical cracks began to appear on the walls and also on the floors. Looking at the nature of cracks, it clearly shows that it was as a result of foundation settlement. This was because the history of site (a refuse dump site) was not considered in the design and construction of the foundation.

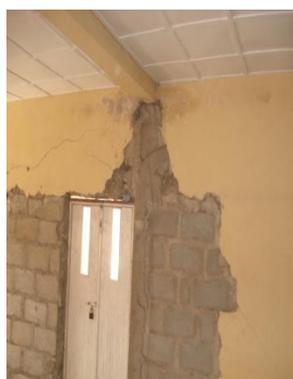
plate iv: Re-constructed column & wall

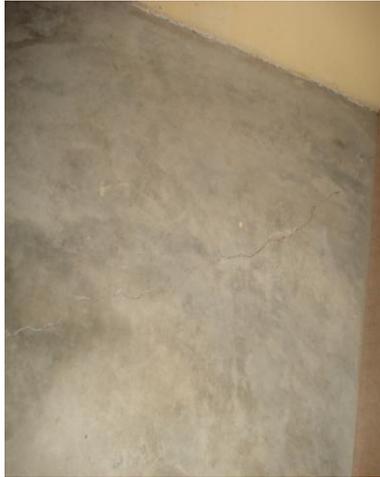
Plate v: Cracks on floors

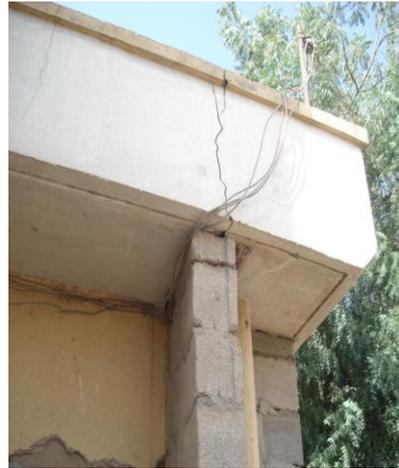
plate vi: cracks on parapet wall
