Means of Escape Assessment Procedure for Hospital's Building in Malaysia.

Adnin Syaza Jaafar¹, Yuhainis Abdul Talib²

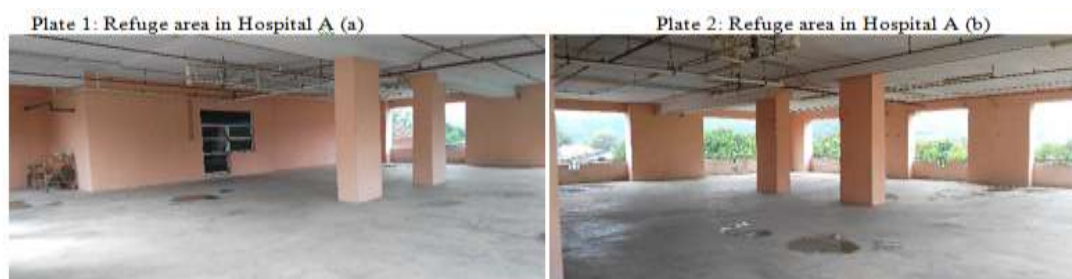
Table 3, only Hospital A had complied with the regulations whereby Hospital D and Hospital E did not provide any refuge area in upper floor. The refuge area has been isolated with the ward by using fire rated door. In addition, the door was constructed with self-closing devices. [8] added that the door should be at least 1-hour fire resistance. To evacuate the occupants in this area, there were two methods which are firstly by using skylight provided by firefighter, and the other one using staircase located near to the refuge area. However, the area was an open area and only depend on the fire rated door to prevent the fire from spreading to the area as in Plate 1 and Plate 2.

3. During design stage, all designer should include the refuge area in upper floor level as one of the area in the hospital's building. This is to ease the evacuation and means of egress.
